Working out the manner and cause of death using medicine, marks and micro traces - Case report

Abstract

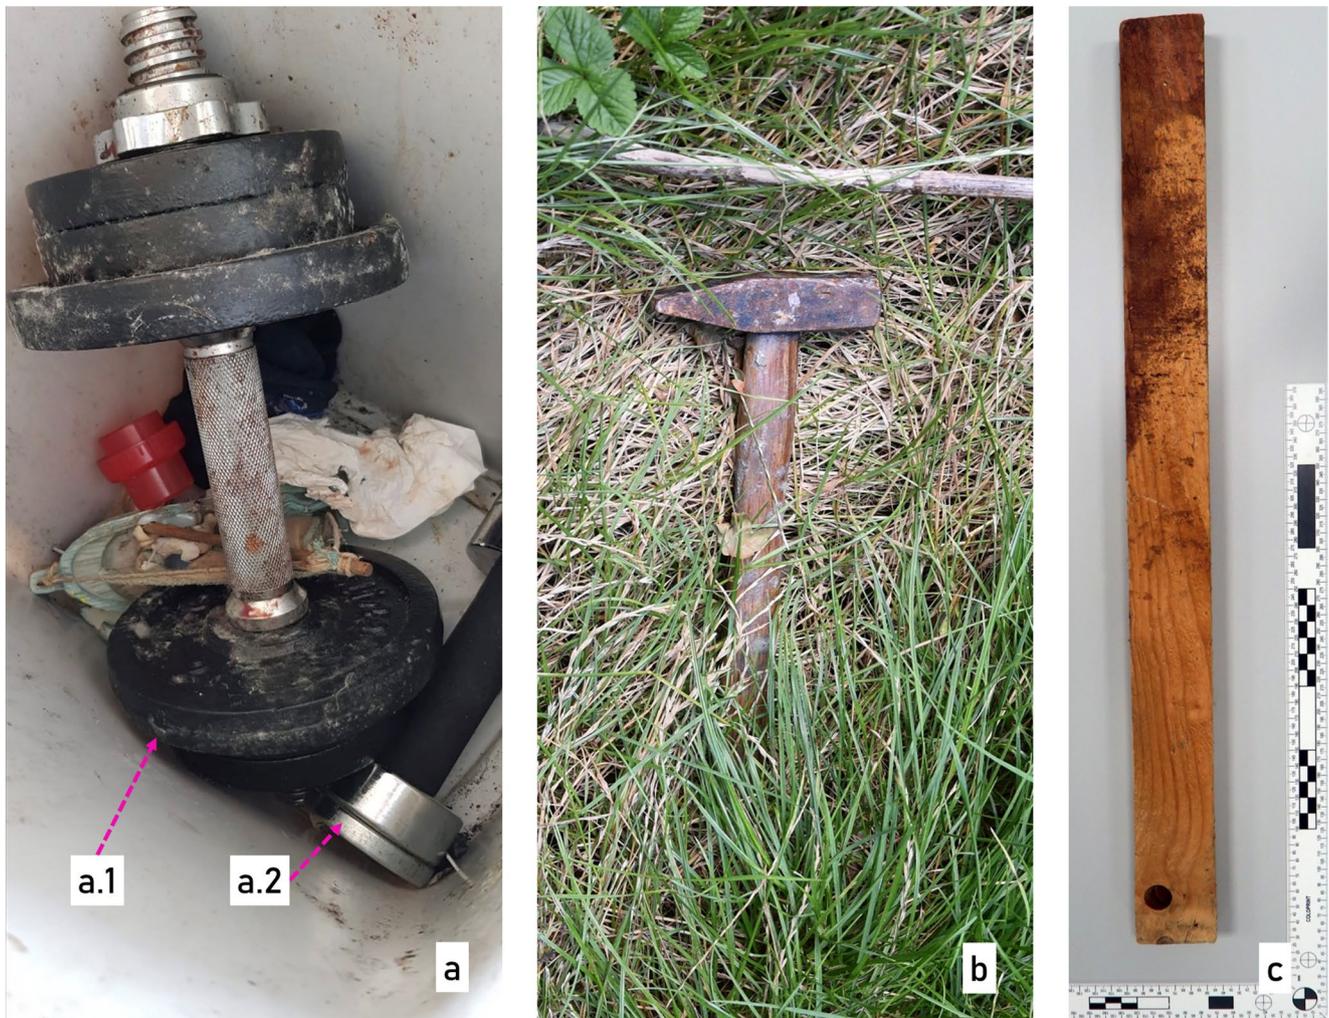
Fig. 1 Possible evidence at the beginning of the investigation. (a) two dumbbells a.1) dumbbell with black painted weight plates and blood stains, a.2) dumbbell with black handle and silver-colored weights, (b)

locksmith's hammer with black coating on hammerhead and wooden handle and (c) wooden slat with bloodstains

Further investigations and the results of the autopsy reinforced the suspicion that this was a homicide. During the subsequent crime scene investigation, four potential weapons were secured: a small dumbbell, a large 8 kg dumbbell, a locksmith's hammer, and a 58 cm long wooden slat (Fig. 1).

The two black-coated potential tools used in the crime, the hammer (Fig. 1b) and the scratched 2 kg weight plate (Fig. 1a1), were sampled and compared with the material samples from the bone using an FT-IR spectrometer (Thermo Fisher, Scientific iN10, infrared microscope, using an IR-diamond cell for preparing a thin, flat sample and measuring in transmission mode). In addition, an elemental analysis of the micro traces from the bone and the weight plate was carried out using SEM-EDX.

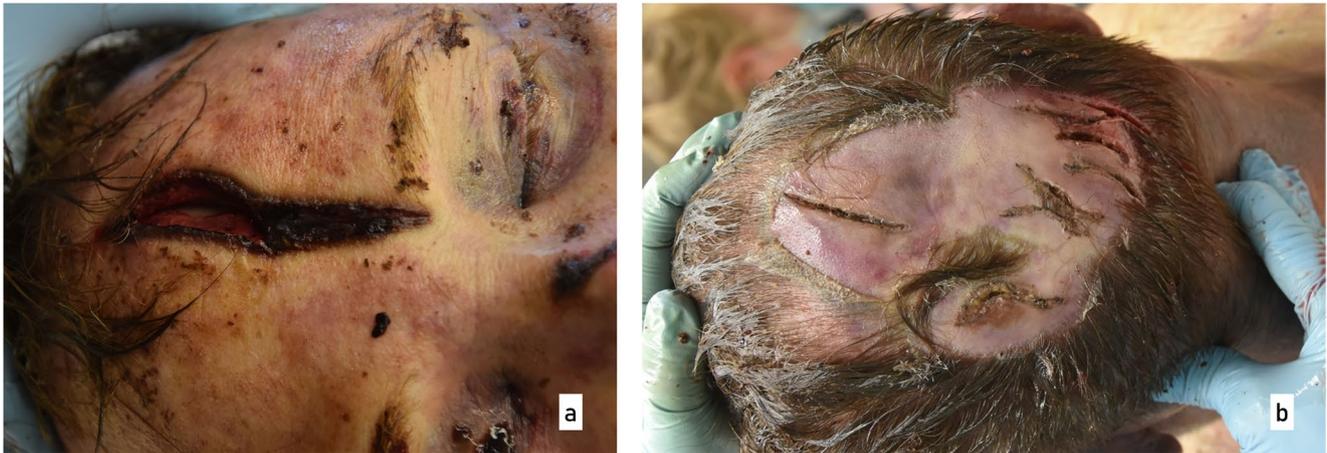
Fig. 2 External visual inspection during the autopsy. Injuries caused by blunt force are shown here as an example on the (a) victim's forehead and (b) the back of the head

Prior to the autopsy, a CT scan was performed. The main findings included midface fractures and a fracture of the frontal bone. During the autopsy, numerous injuries to the victim's head were observed (Fig. 2). In the area of the back of the head, right ear, upper lip, chin and forehead, several lacerations were found resulting in tearing and splitting of the tissue. The most prominent of these was a laceration on the forehead, which appeared as a wide gaping injury with damage to the underlying skull bone. Examination of

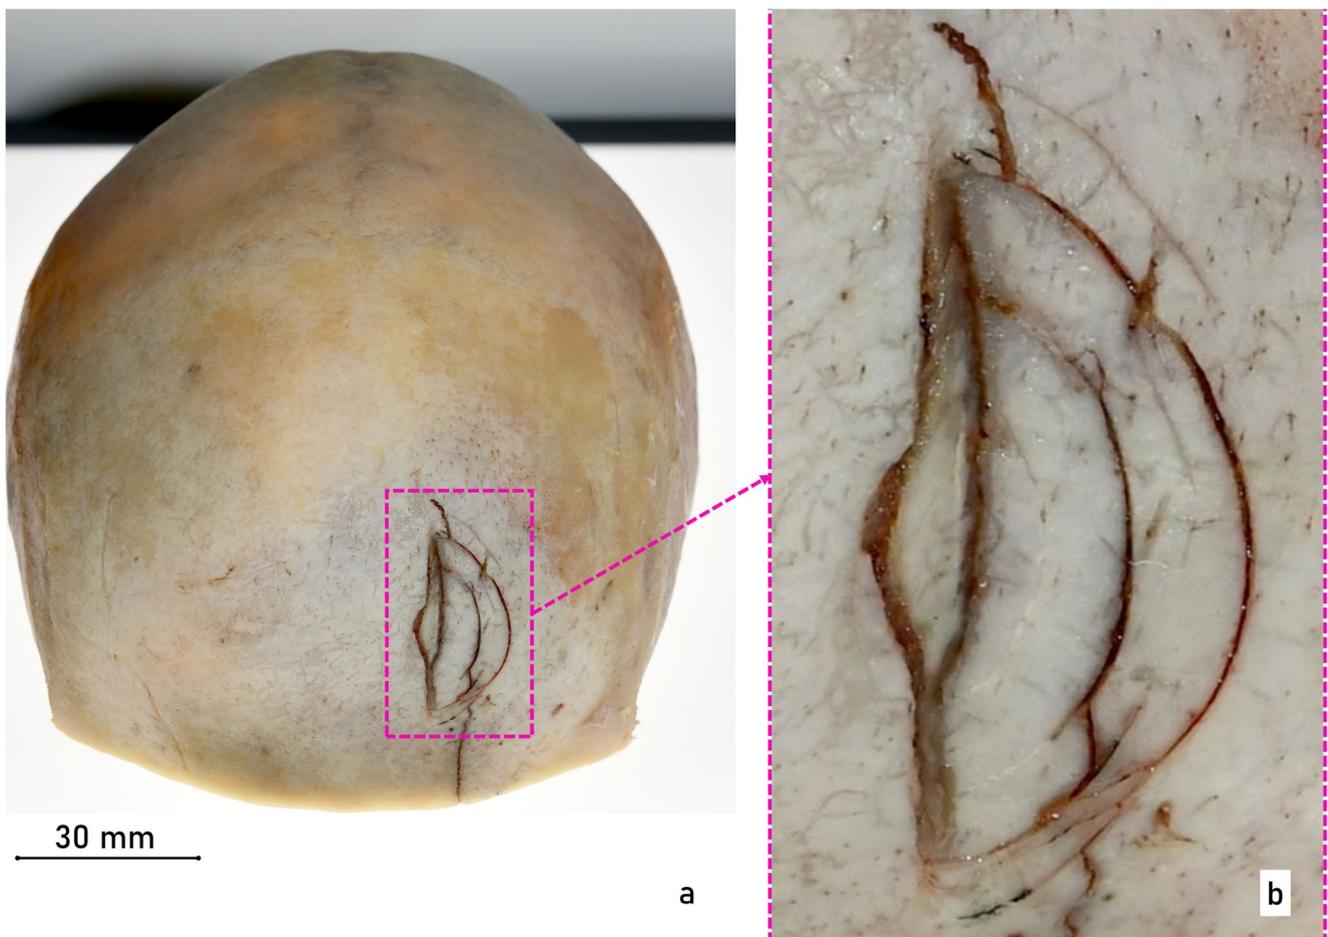
Fig. 3 Macerated cranial vault (calvarium) (a) semicircular fractures of the left frontal bone (overview) and (b) detailed, microscopic image of the fractured area

the skull bone revealed a single depressed fracture located approximately centrally on the frontal bone (os frontale). For further analysis, the calvarium was macerated in warm water without additives. The fracture exhibited relatively

straight edges with adjacent, approximately concentric, semi-circular and relatively fine cracks (Fig. 3). Based on the injuries to the soft tissue and bone, however, it was not possible to identify the weapon used, partly because of tissue

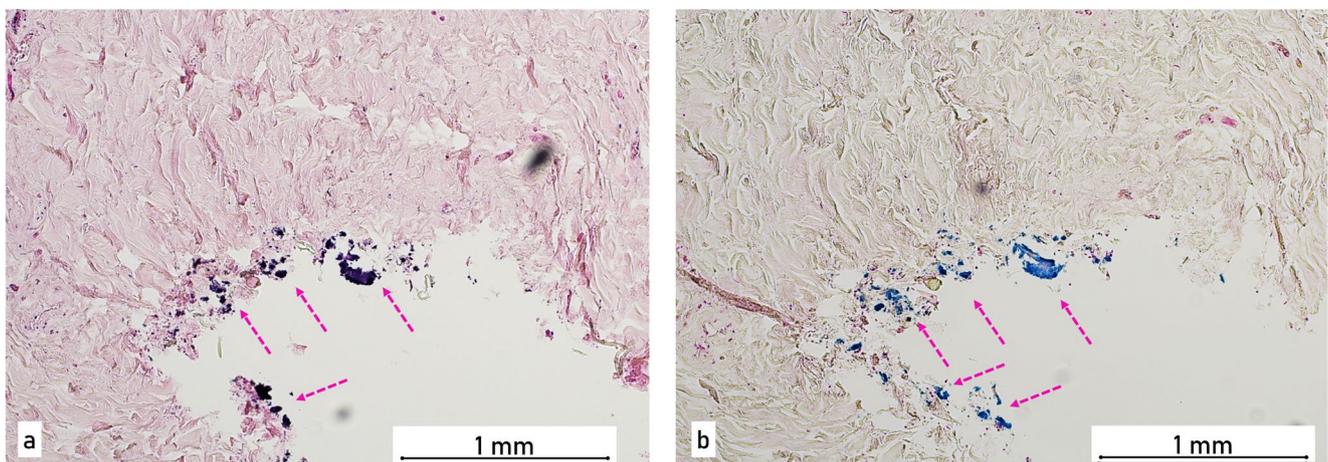
Fig. 4 Histological images of the wound edges of one of the injuries on the back of the head 10X magnification (a) staining with Hematoxylin and Eosin (H&E), (b) iron staining with Prussian Blue

Exemplary samples were taken from the skin and soft tissue of the head injuries for histological examination, in particular to estimate the age of the wounds. After being cut, the samples were embedded in paraffin and stained with haematoxylin-eosin and prussian blue. In some samples, including the wound on the forehead and four injuries at the back of the head, ferrous foreign material was detectable in the tissue of the wound edge. (Fig. 4). In addition, accumulations of erythrocytes and, in some cases, large numbers of granulocytes indicated that the bleedings were not entirely fresh.

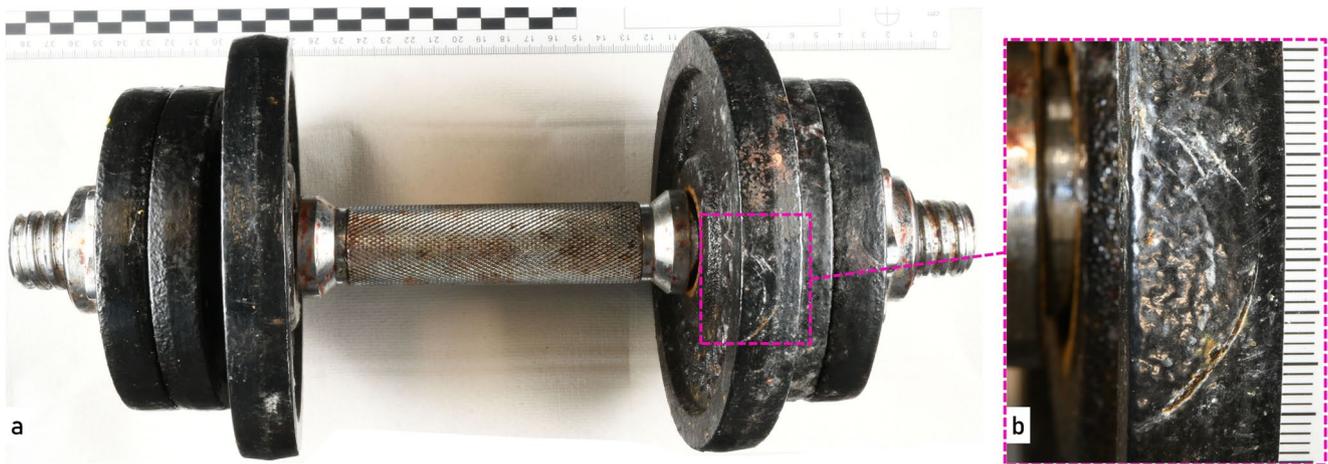
Fig. 5 (a) overview of the dumbbell with two 2 kg and four 1 kg weight plates and (b) detailed view of the scratch marks in the black coating of one of the 2 kg weight plates

the 2 kg weight plates in the form of superficial scratches in the black paint. The shape of the scratches can be described as approximately concentric and semi-circular and therefore like the cracks found on the fractured skull bone (Fig. 5).

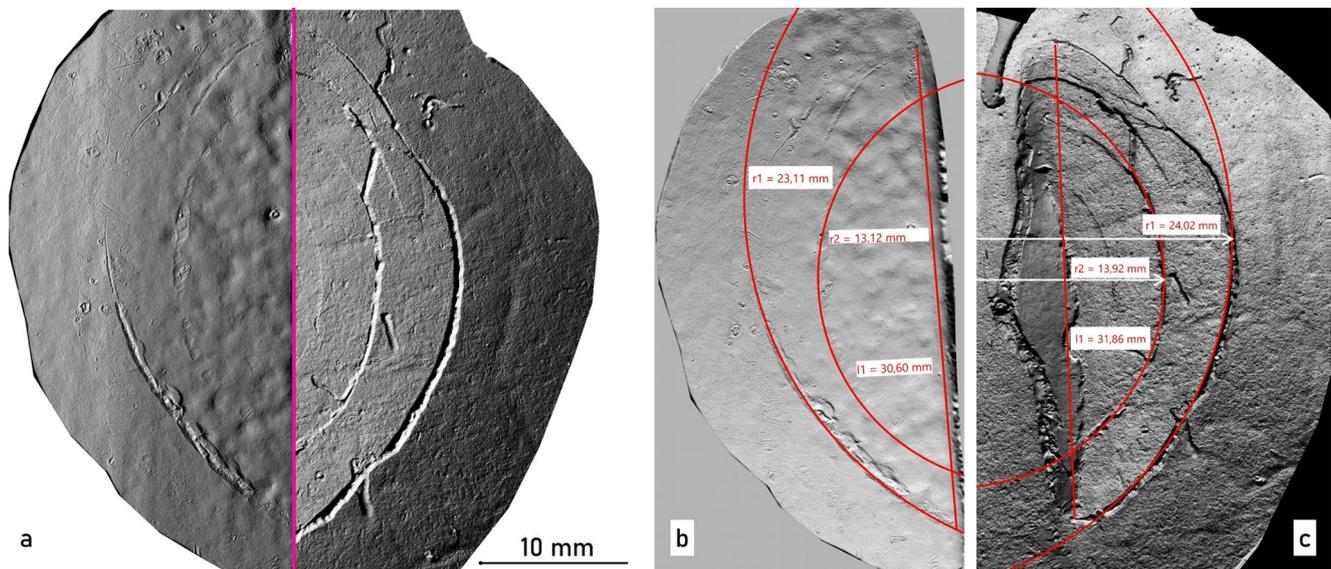
Fig. 6 3D-scanned silicone casts of the surfaces of bone and dumbbell. (a) Comparative view: scratch marks on the weight plate (left) and cracks within the fracture of the skull bone (right). (b) Measurement

of scratch marks on the surface of the weight plate. (c) Measurement of cracks in the cranial vault

Casts of the scratch marks on the 2 kg weight plate and of the fracture cracks on the skull bone were then made using silicone compound (AccuTrans AB brown, Coltène Whale-dent). The casts were scanned using a 3D surface scanner (ToolScan, LIM) and the subsequent comparative examination revealed similarities in shape, orientation, and size between the scratch marks on the dumbbell weight plate and the fracture cracks found in the skull bone (Fig. 6).

In the present case, the result of the mark examination was that the similarities found between the crack structures in the skull bone and the shape of the scratch marks in the paint coating on one of the 2 kg weight plates indicate that both surface alterations (weight plate, bone) were caused by the violent impact of the dumbbell on the skull bone.

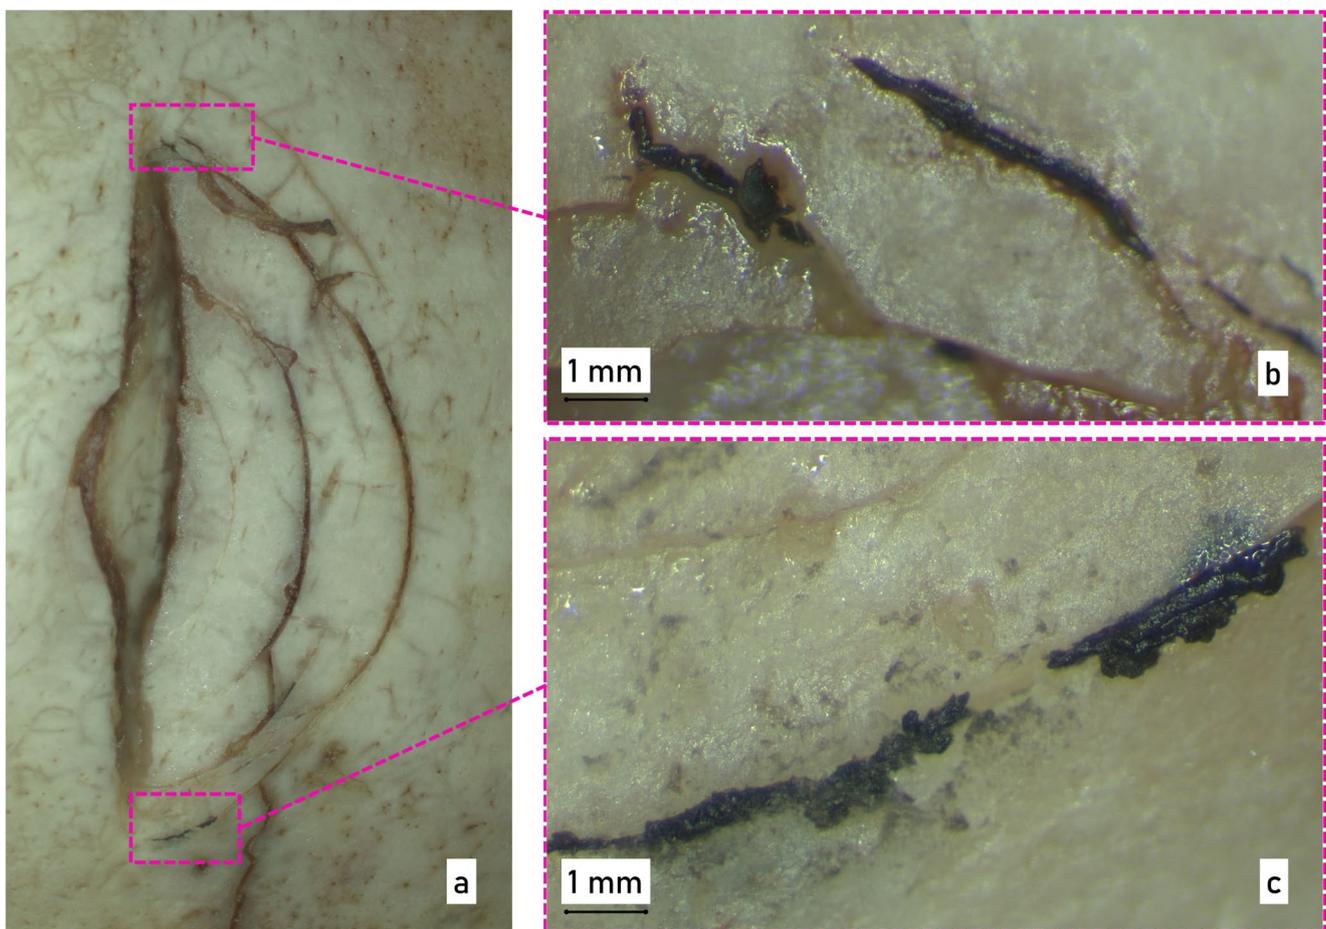
Fig. 7 Microscopic Images of (a) the surface cracks in the bone, (b) and (c) detailed images of the material traces found in the cracks

At the beginning of the micro trace investigation, the macerated bone was carefully examined under a reflected light, stereo microscope (magnification up to 100x). The examination revealed conspicuous black material adhering to the outer bone plate (Fig. 7). The particles appeared to have been rubbed into the cracks and are therefore likely to have been caused by the object used in the crime.

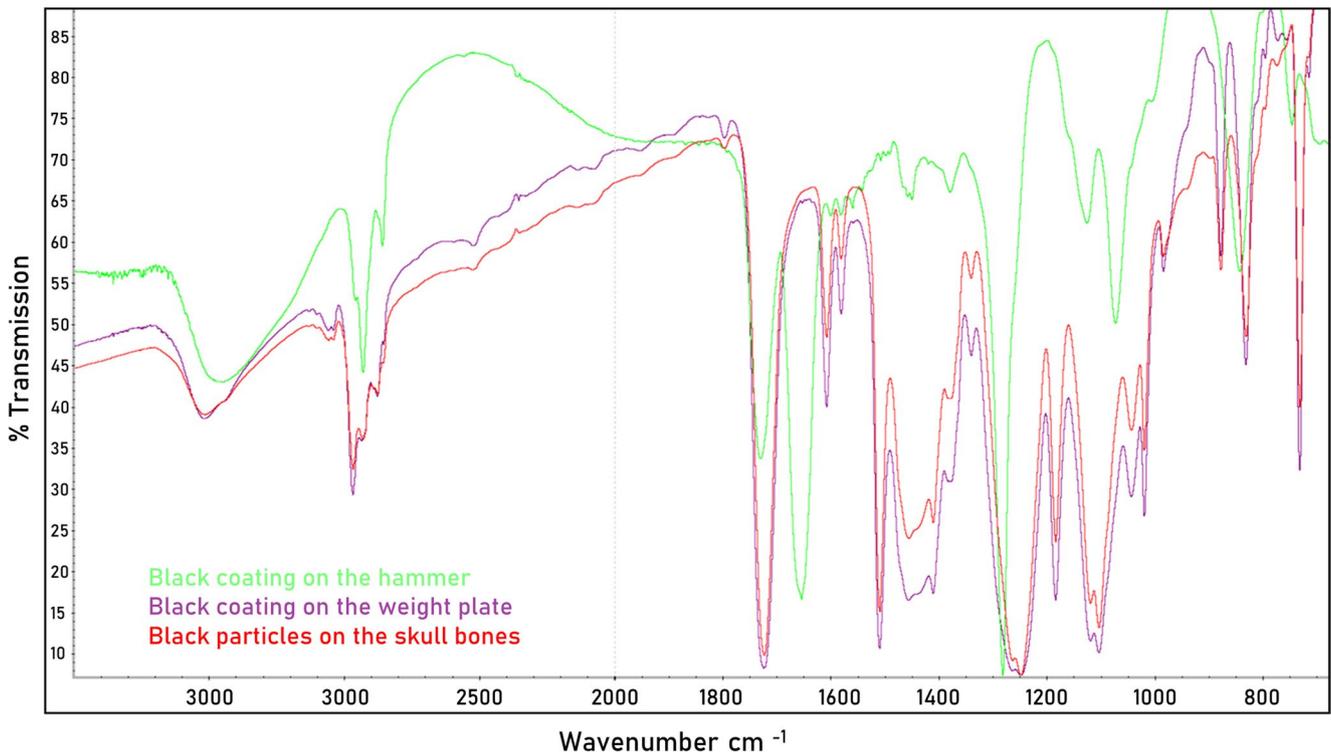
Fig. 8 FT-IR spectra matching of the samples from the weight plate (purple spectra), the hammer (green spectra) and from the bone (red spectra)

Due to the non-identical FT-IR curves, the black coating of the hammer could be excluded as the source of the black material traces in the victim's skull. The FT-IR spectra as well as the elemental composition of the black material traces on the skull and the material of the dumbbell coating (Fig. 8) were indistinguishable from each other and corresponded to a polyester-based coating paint. In general, black polyester-based paints are widely used in the field of coating materials. The micro trace analysis showed that the material in the cracks in the bone was indistinguishable from the paint coating on the 2 kg weight plate, providing moderate support for the hypothesis that the black coating particles originated from the dumbbell and not from another object. However, the material traces do not permit a conclusive identification of the dumbbell as the specific weapon used, as an indeterminate number of objects may share the same type of coating. Nevertheless, the findings represent a significant indication and, in conjunction with the results of other applied forensic disciplines, carry considerable evidentiary value.
